# Inspection Report

**America's Home Checkers**

**Date:** 6/17/2014

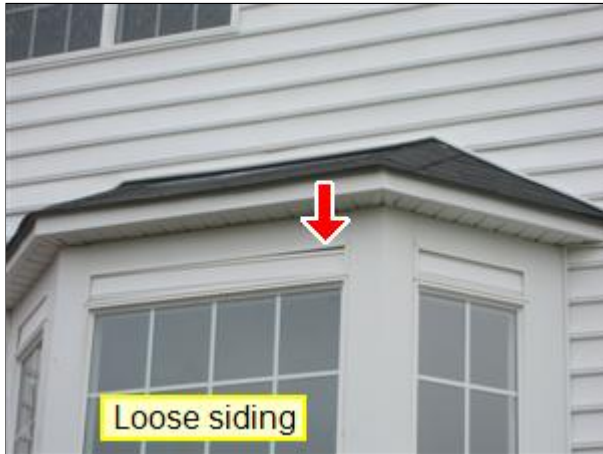
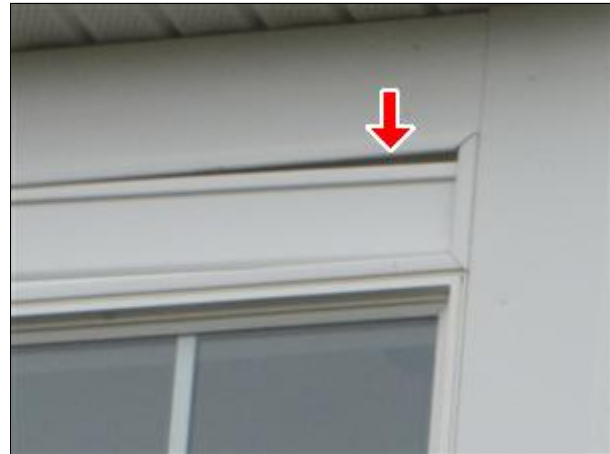
**1.0** Loose/ fallen vinyl siding at top of the rear bay window. Repair is needed to avoid water entry.

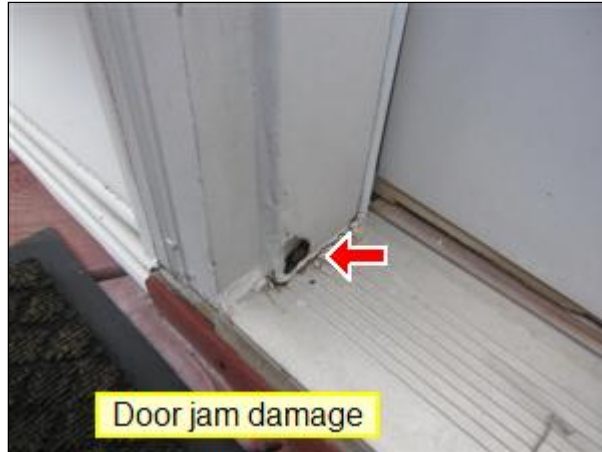
1.1 Picture 1

1.1 (1) The door jam at the rear entry door is damaged. Further deterioration may occur if not repaired. A qualified person should repair or replace as needed.

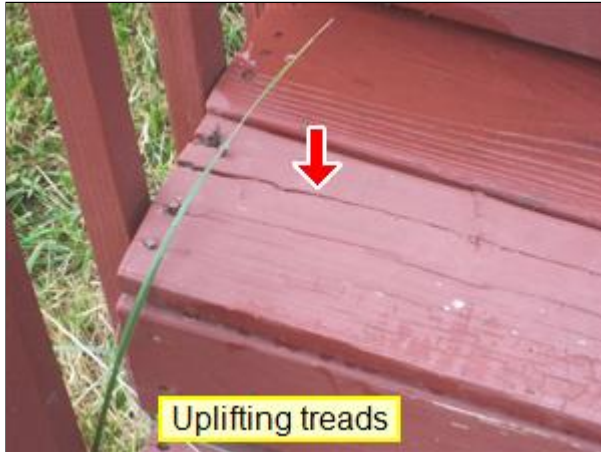
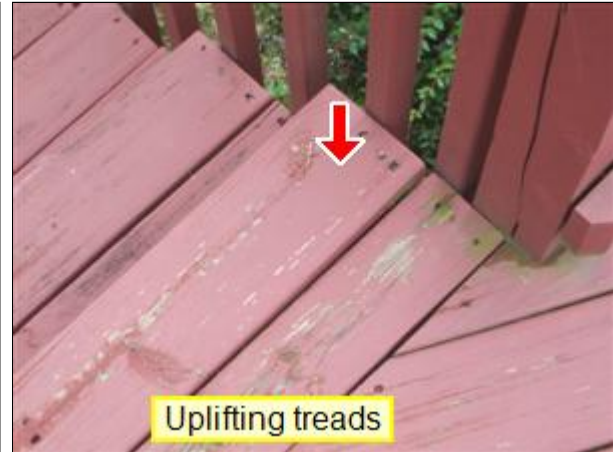
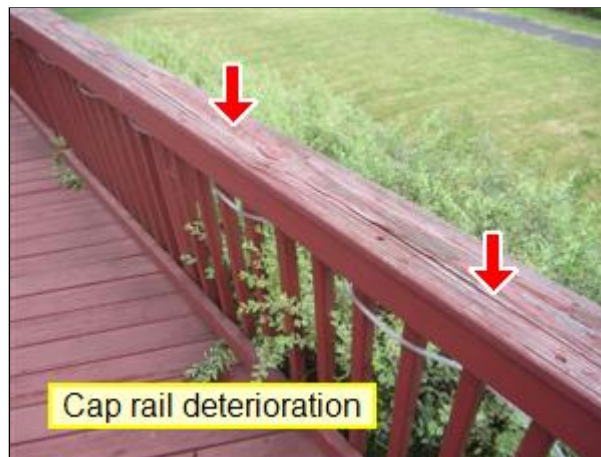
**1.3** Several loose stair treads were present at the rear deck steps and deterioration at the rear deck railing cap rail. Repairs are needed for personal safety.

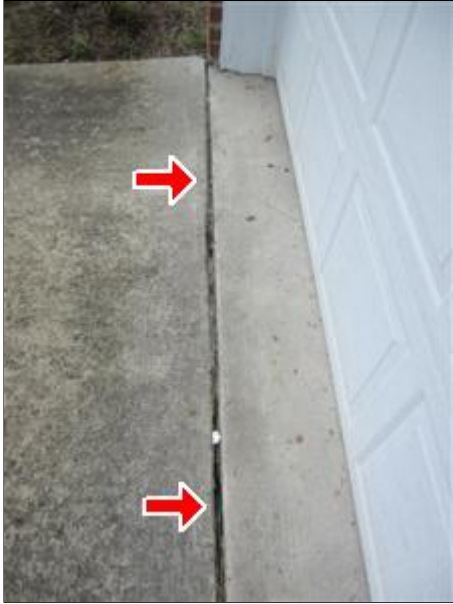
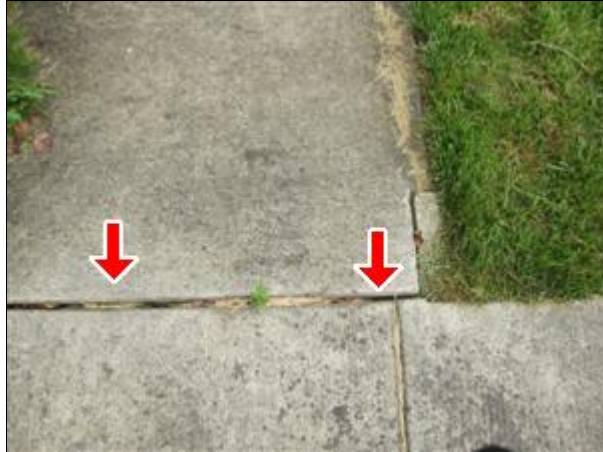
**1.4** (1) The masonry felt in the driveway and sidewalk is deteriorated. Recommend replacing to avoid water entry and settlement. Repairs needed by a qualified contractor.

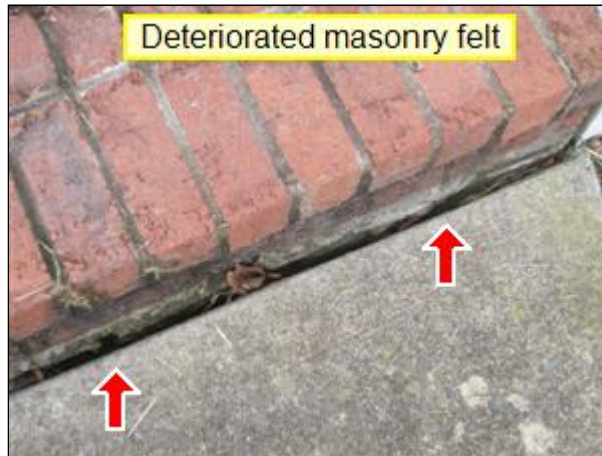
1.4 Picture 3

(2) The masonry felt between the sidewalk and front steps is deteriorated. Recommend replacing to avoid water entry and settlement. Repairs needed by a qualified contractor.

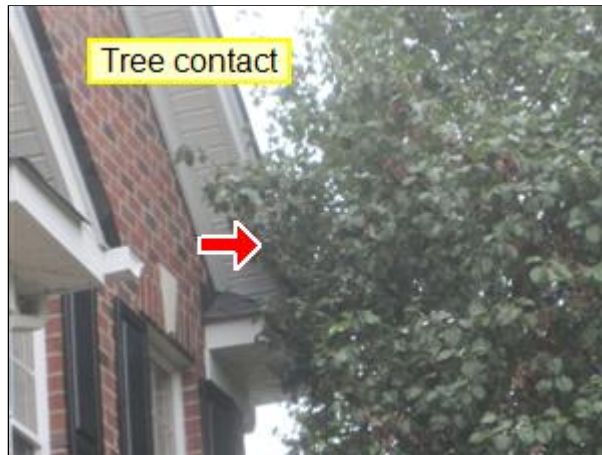
1.4 Picture 4

🏠 (3) Tree limb contact with the structure and or roof at the right front of home. Recommend cutting back to avoid contact damage. Repairs needed by a qualified person.

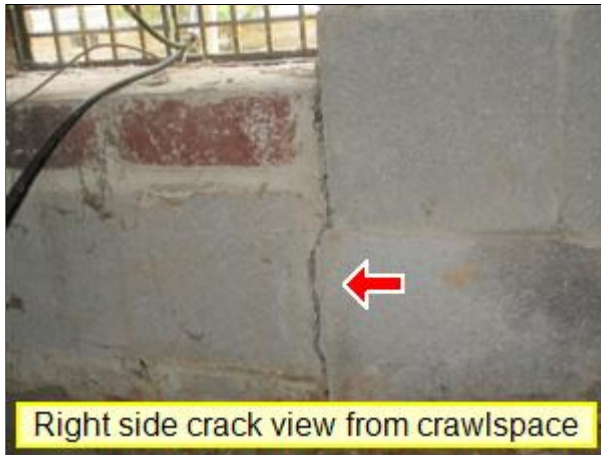
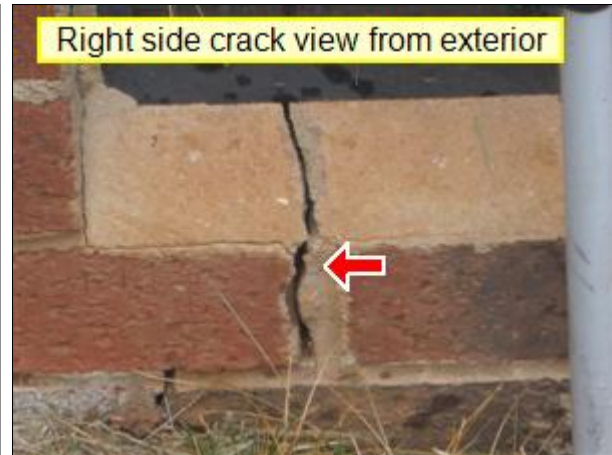
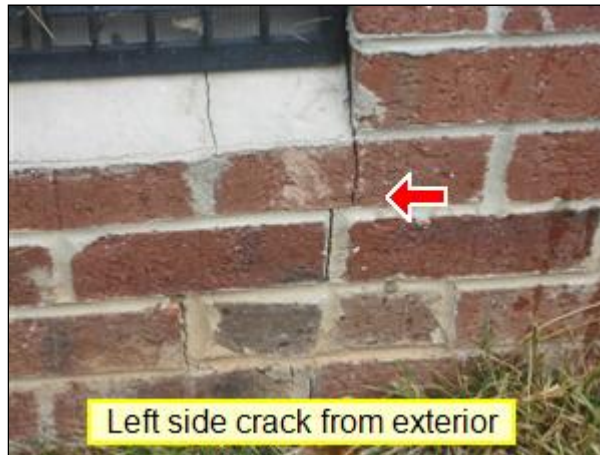
**2.0** There are foundation cracks observed at the left and right side of the foundation due to past settlement. The spanker system may be contributing to the settlement as a result of saturated sods next to the structure. Unable to determine if these conditions will worsen however it is recommended that all moisture next to the structure be eliminated, seal cracks to avoid water entry causing freeze expansion damage and monitor. If these cracks worsen. stability repairs will be needed.

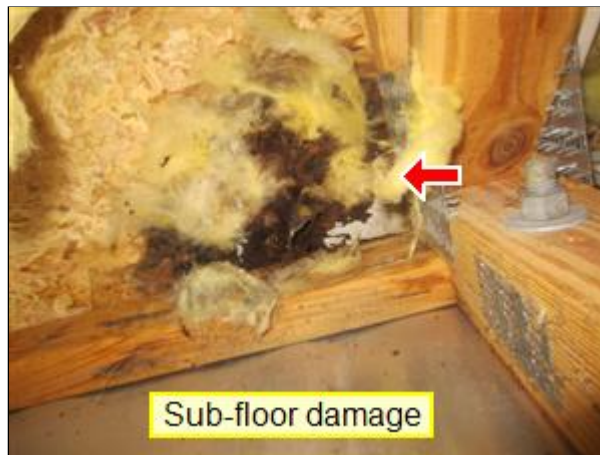
2.3 Picture 1

**2.3** Moisture damage to the sub-floor behind the rear entry door. Repairs are needed by a qualified contractor.

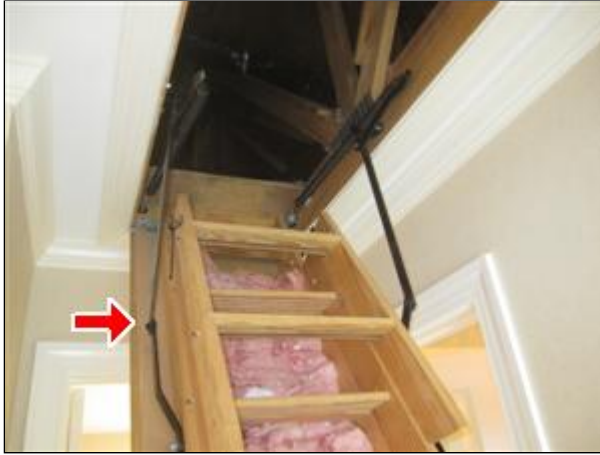
2.5 Picture 1

2.5 There is a sprung hinge at the attic pulldown stairs. This makes closure more difficult.

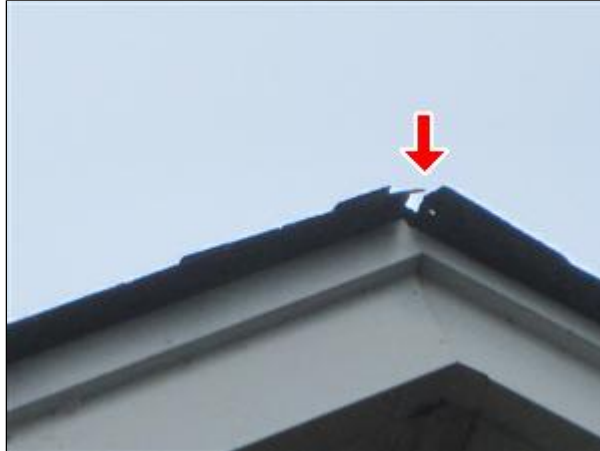
3.0 Picture 1

**3.0** (1) Damaged ridge shingle at the front gable ridge peak. Repair is needed to avoid water entry and trim damage.

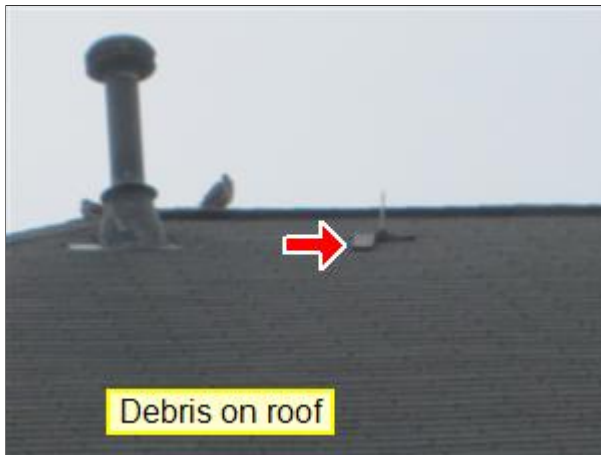
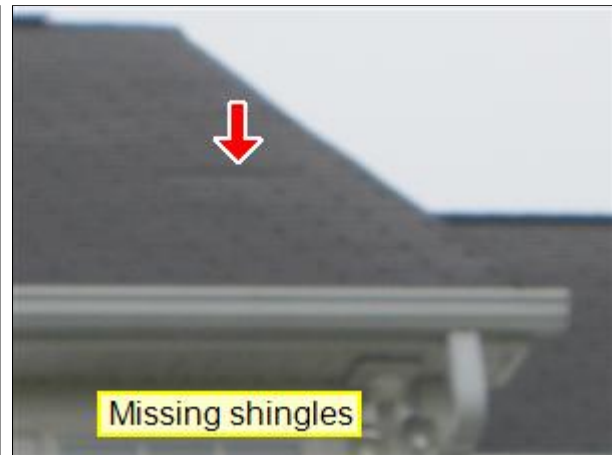
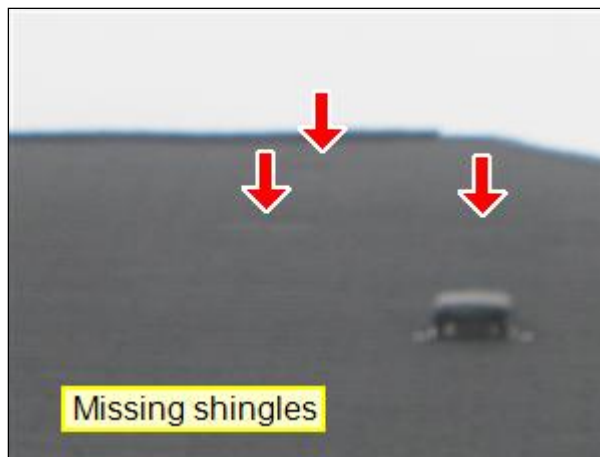
(2) Several missing shingle tabs at the rear roof and debris observed on the roof next to the tethers arm. Repairs are needed by a roof contractor to avoid roof leakage.

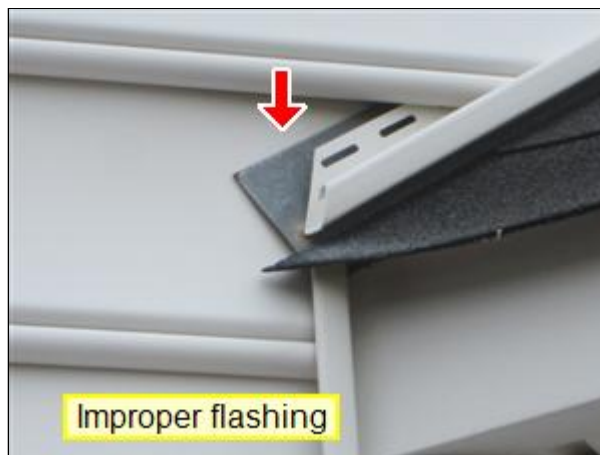
3.1 Picture 1

3.1 The flashing at the rear bay window is improper. The flashing should be behind the vinyl siding to avoid leakage behind the siding.

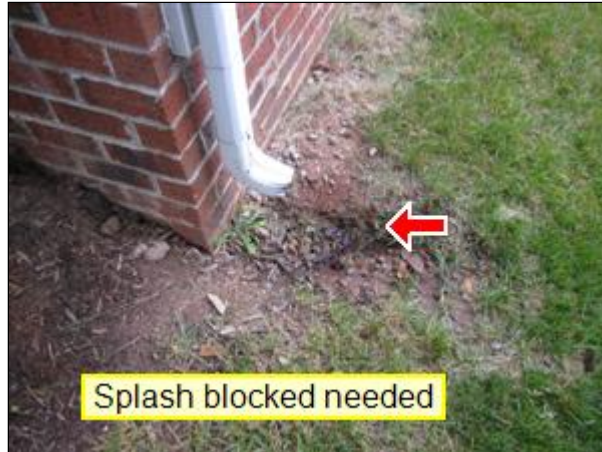
3.3 Picture 1

**🏠 3.3** Splash blocks or plastic piping needed to divert gutter / roof drainage away from the structure. Excessive crawlspace or perimeter moisture can cause structure settlement,

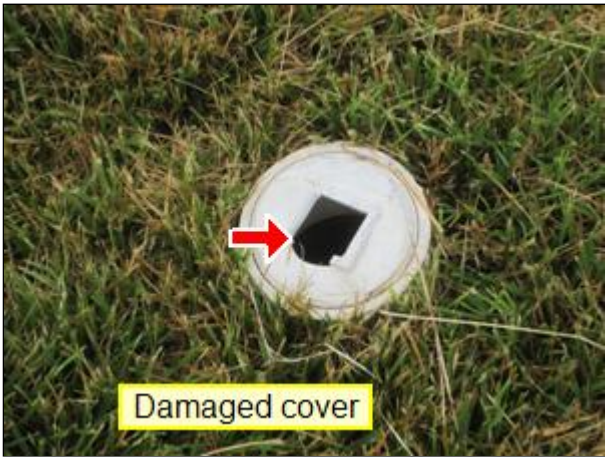
4.5 Picture 1

4.5 Damaged sewer cleanout cover at the rear yard. A replacement is needed to avoid debris and or pest entry.

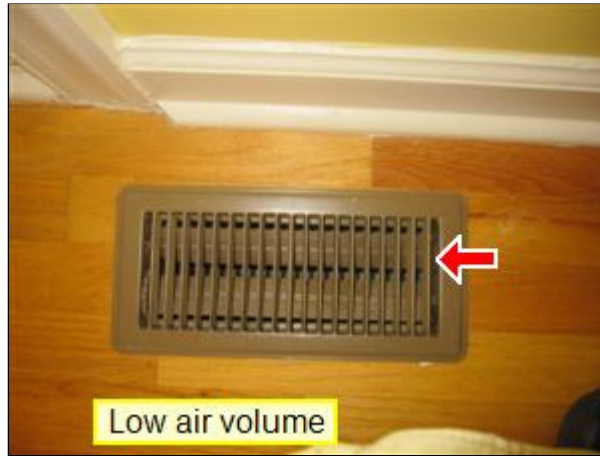
5.3 Picture 1

🏠 5.3 Very low air volume at the 1st floor supply registers. Evaluation is needed by a licensed HVAC contractor.

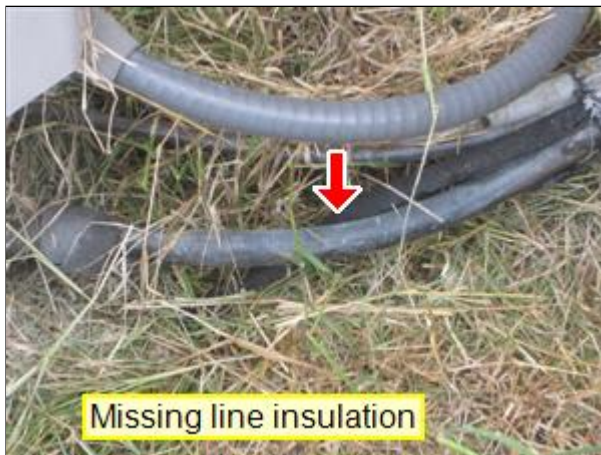
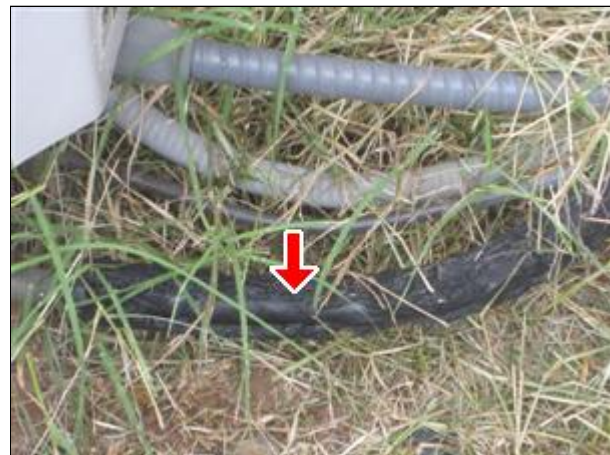
🏠 (2) The foam sleeve on the suction line is deteriorated in area(s) at the outside units. Missing foam on suction line can cause energy loss and condensation. I recommend service or repair as needed.

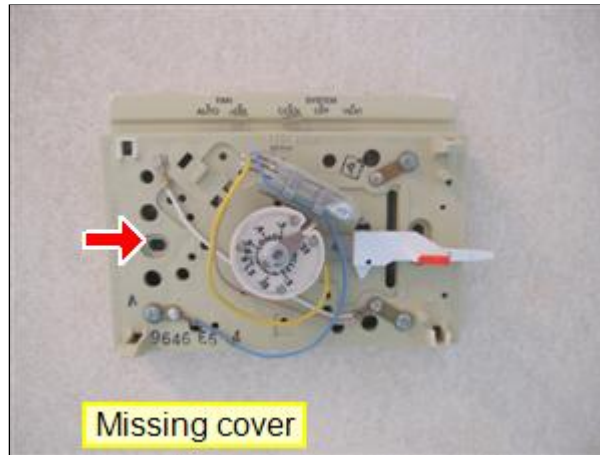
5.7 Picture 1

5.7 Missing thermostat cover at the upstairs. A replacement is needed.

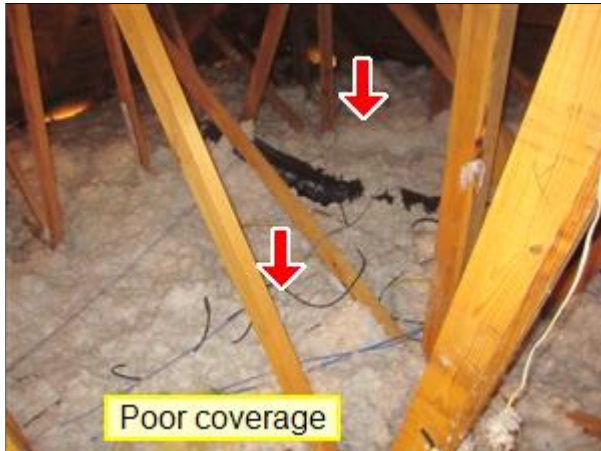
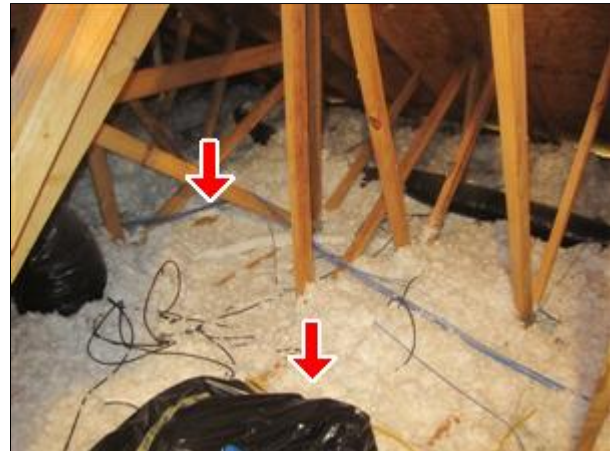
**6.0** The attic insulation has been disturbed causing poor coverage in some areas. Recommend redistributing to avoid heating and cooling loss.

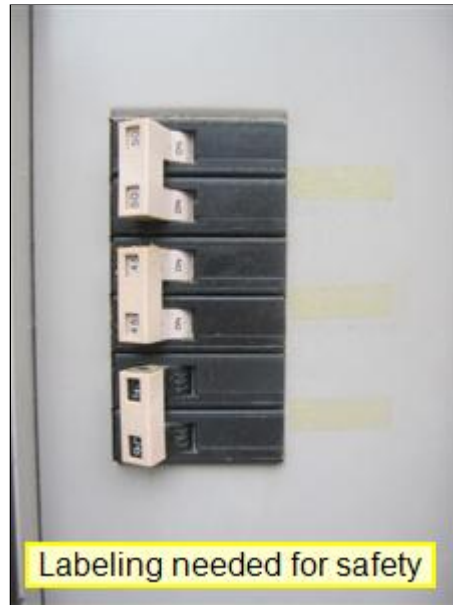
7.2 Picture 1

- 7.2 The main panel has three circuit breakers that need labels identifying their location(s).

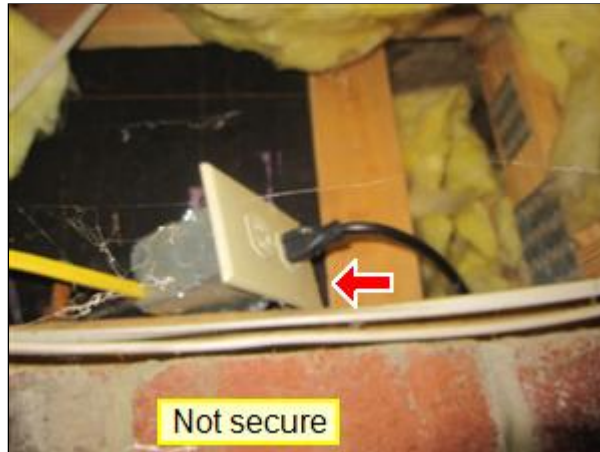
7.4 Picture 1

- 7.4 Unsecured outlet box at front of crawlspace. All boxes should be secured for electrical safety.

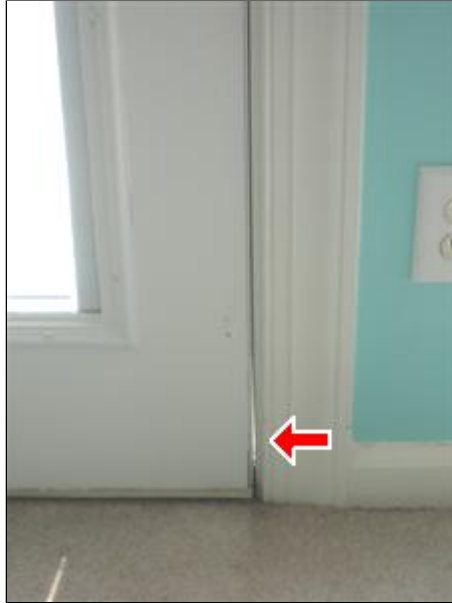
8.0 Picture 1

**8.0** Daylight is visible at the rear entry door. Adjustment is needed to avoid heating and cooling loss or water entry.

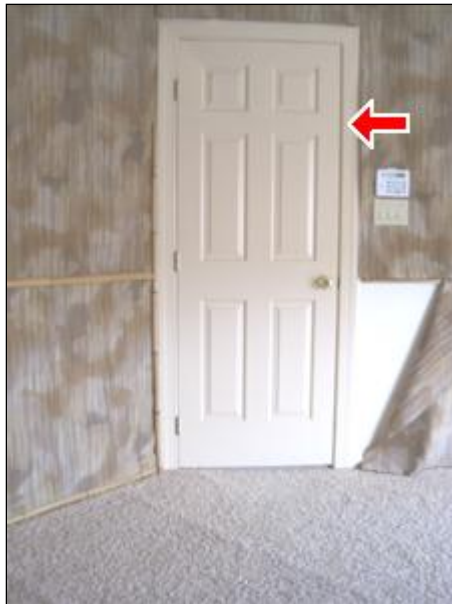
8.1 Picture 1

**8.1 (1)** The bedroom door rubs at jamb when closing at the master bedroom. This makes the door more difficult to operate.. A qualified person should repair as needed.

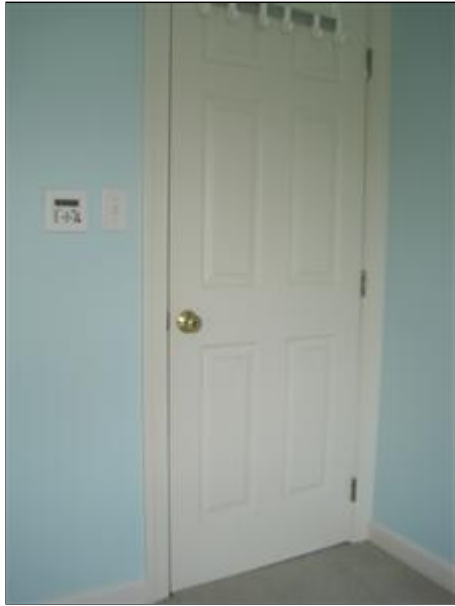
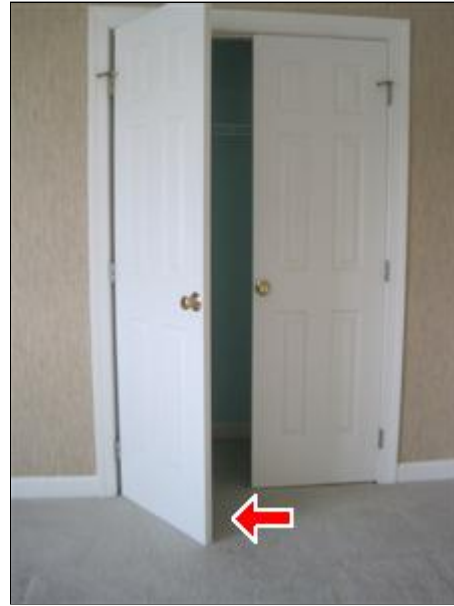
(2) The bedroom door rubs on the carpet at the upstairs rear center bedroom and the closet in the bonus room. This can cause the carpet to wear faster in that area and make the door more difficult to operate. A qualified person should repair as needed.

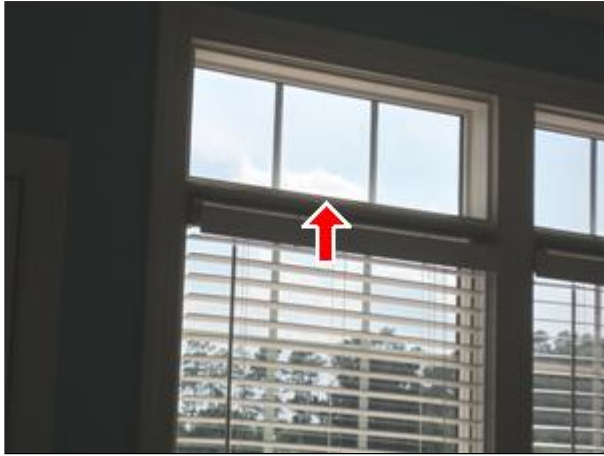
**8.2** One fixed pane window is cloudy (lost seal) at the family room and deteriorated glass sealant at in rear window. In order to correct the cloudy appearance of glass, a replacement of glass pane or the unit will be necessary. A qualified window/door professional should replace as needed.

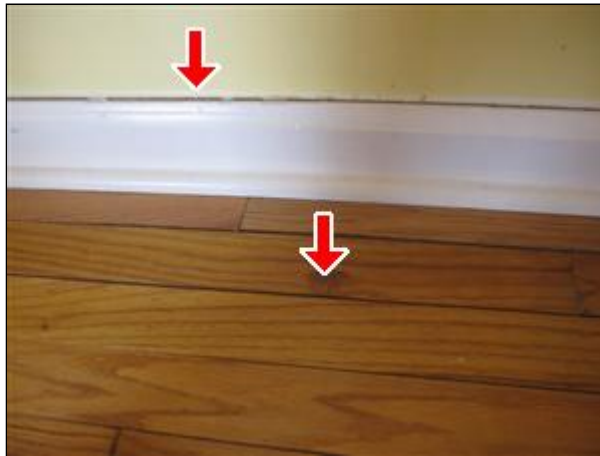
8.5 Picture 1

**8.5** Some wood floor separation and bowing baseboard trim in the pantry due past moisture exposure. No leak was observed at time of inspection.

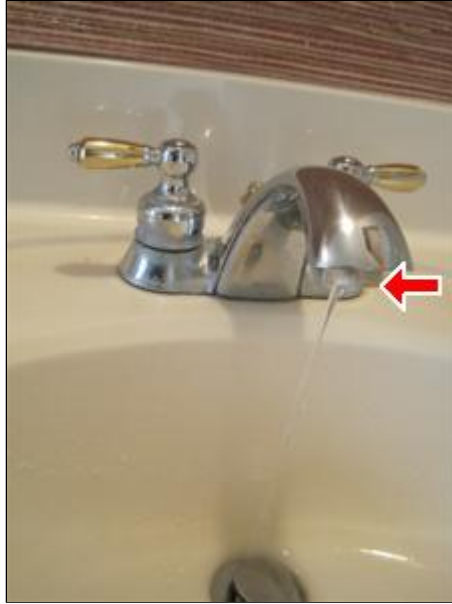
8.10 Picture 1

**8.10** (1) The faucets at the right sink in the master bath and the left sink at the upstairs hall bath does not shut off properly. Repairs are needed. I recommend a licensed plumber inspect further and repair as necessary

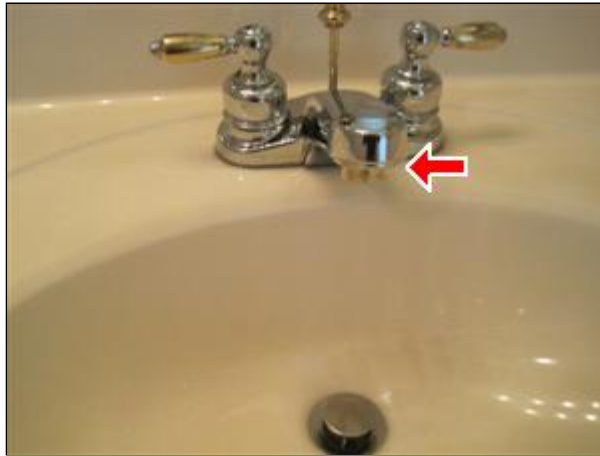
8.10 Picture 2

**8.10** (2) The right sink faucet at upstairs hall bath is leaking at the faucet. Repairs are needed. I recommend a licensed plumber inspect further and repair as necessary

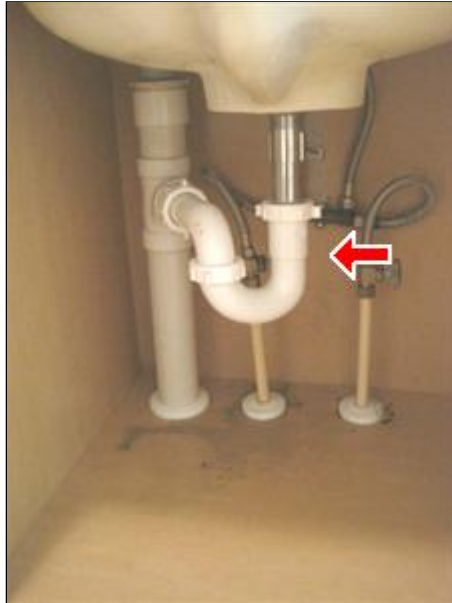
8.10 Picture 3

🏠 (3) There is a major leak below the left sink at upstairs bath when you turn the water valve on at the hot water side. Repairs are needed. I recommend a licensed plumber inspect further and repair as necessary.

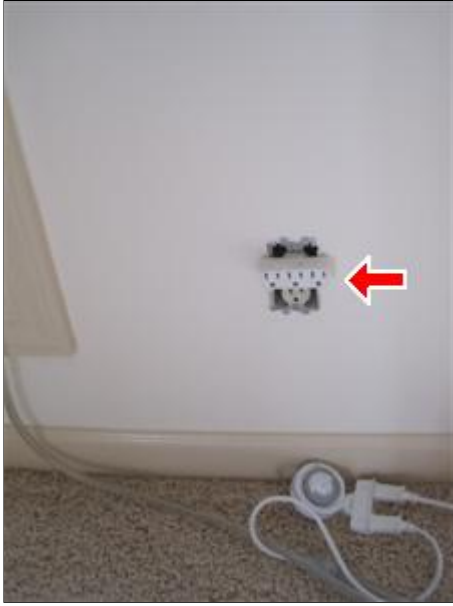
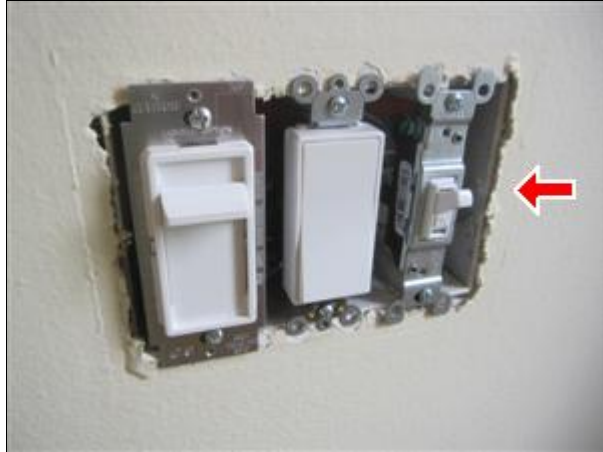
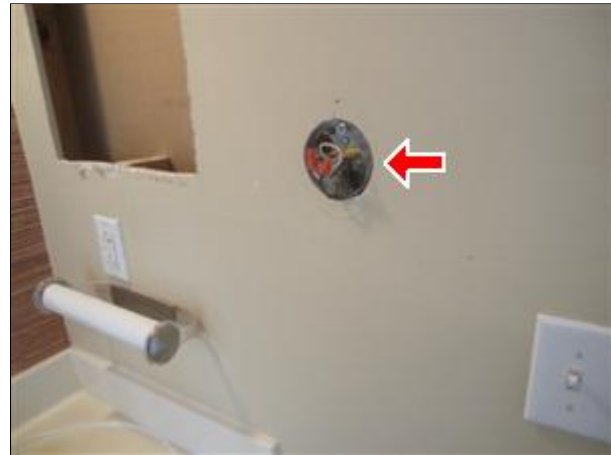
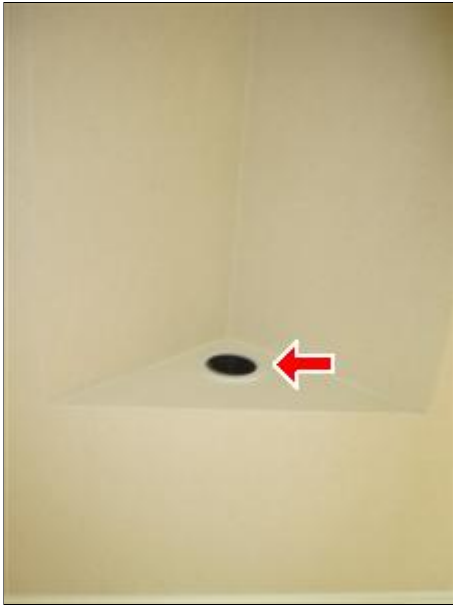
**8.15** (1) Several missing cover plates and missing light fixtures throughout the house. Repairs are needed for electrical safety.

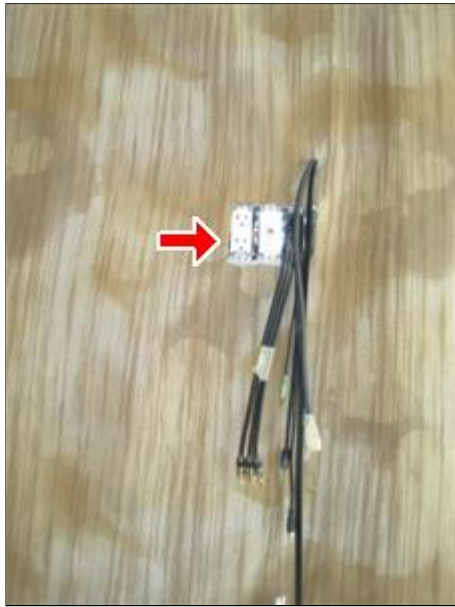
🏠 (2) There are two outlets up high on the wall, one in master bedroom and one in the upstairs rear center bedroom that is not working. Electrical issues are considered a hazard until repaired. I recommend repair as needed.

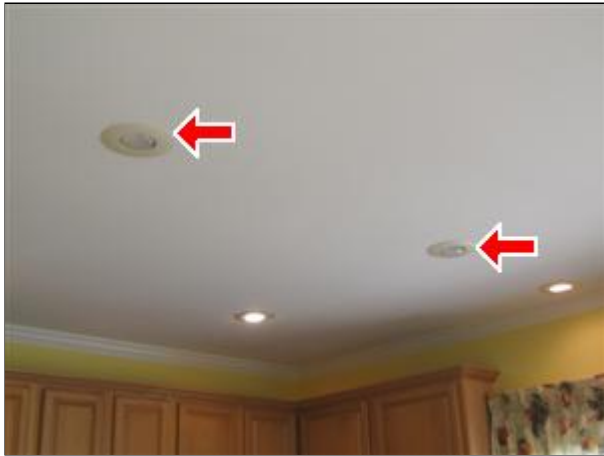
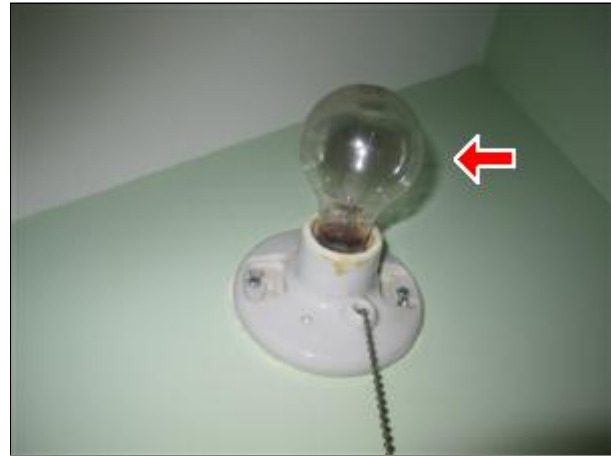
🏠 (3) Two kitchen lights and one launch room closet light were not operational. Repair as needed.

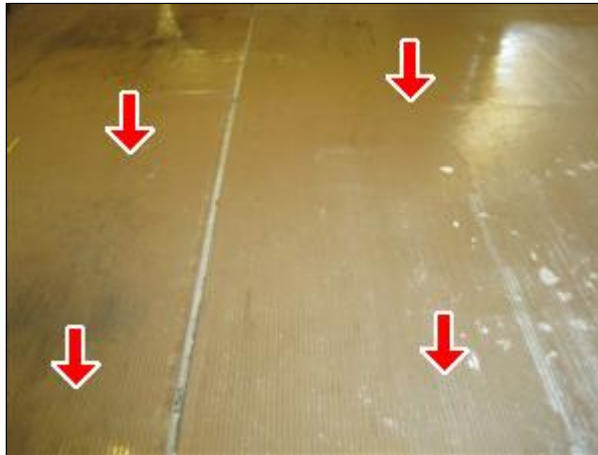
9.2 Picture 1

**9.2** The rubber covering on the floor at the garage could be a fire hazard. This is for your information.
